# Inspection Report

## NRVIA RV Inspection Training Report

9024 US Hwy 175  
The Little / Big Red School House  
Athens TX 75751

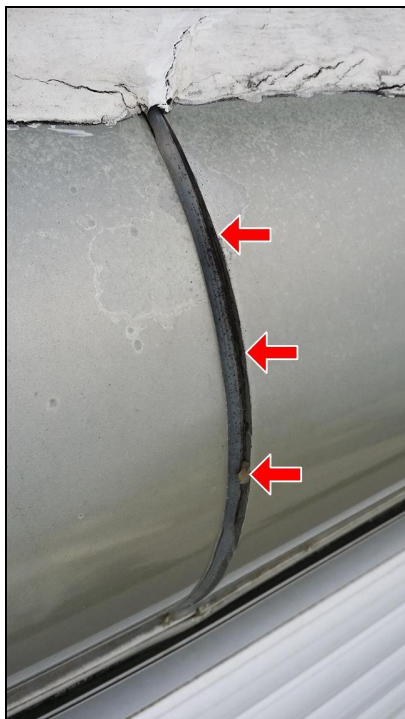
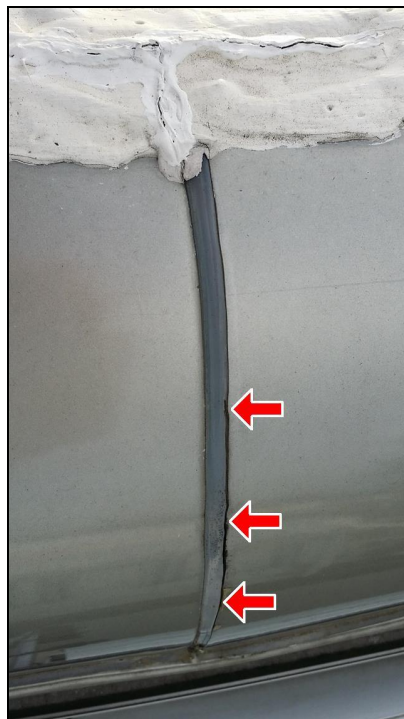
### 2.1 Front Cap, Joints and Seals

There are two areas above the middle part of the awning where the sealant has failed. These areas can be identified as they are located where the roof cap pieces join together. It is recommended that these two areas be repaired by a qualified RV technician to prevent future water intrusion.

Poor

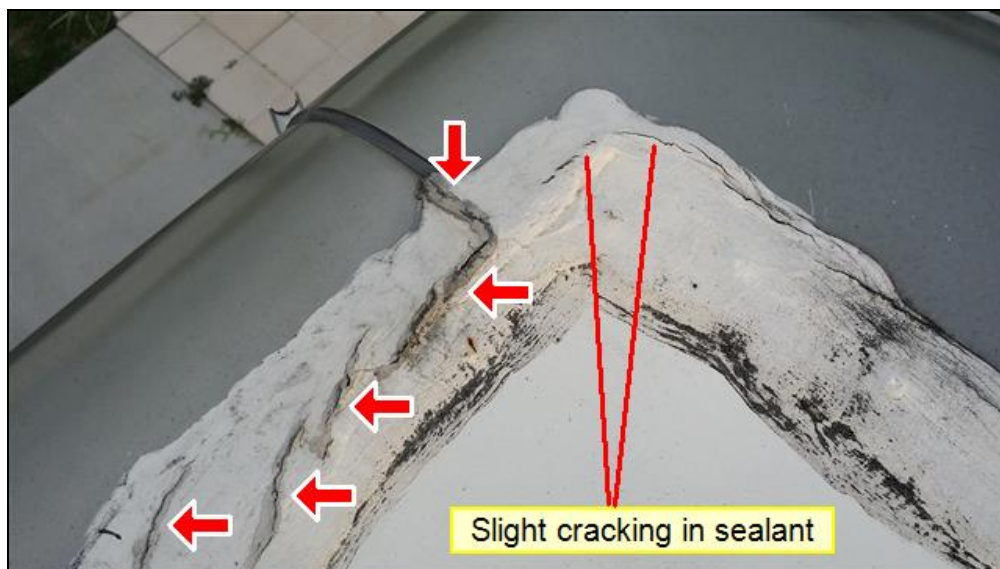
## 2.3 Rear Cap, Joints and Seals

On the curbside rear corner there is silicone sealant that has been applied over the lap sealant. There is also slight cracking of the sealant at the curbside corner joint. It is recommended that these areas be repaired by a qualified RV technician.

Fair

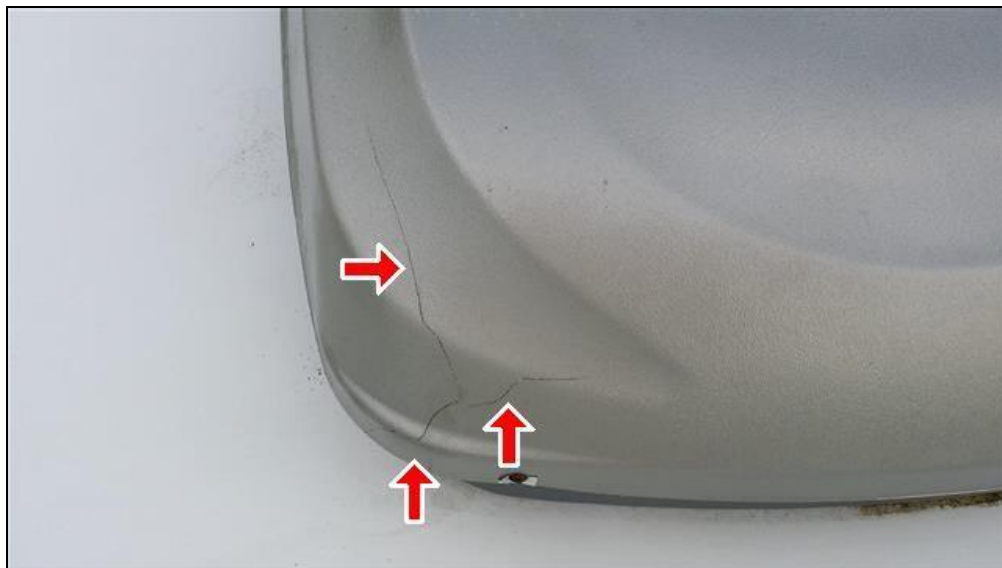
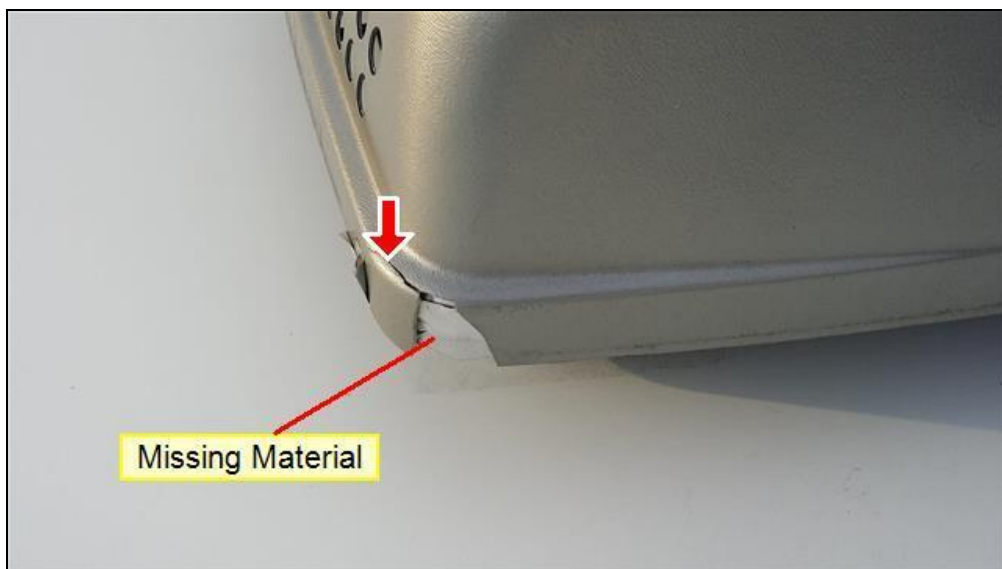
**2.11 Air Conditioner #1 (Shroud)**

**Front Air Conditioner Unit:** There are cracks in the front and back of the air conditioner shroud by the attachment screws. There is also a piece of the cover that is missing on the back of the lower left corner. Shroud replacement is recommended to avoid having it fly off at highway speeds.

Poor

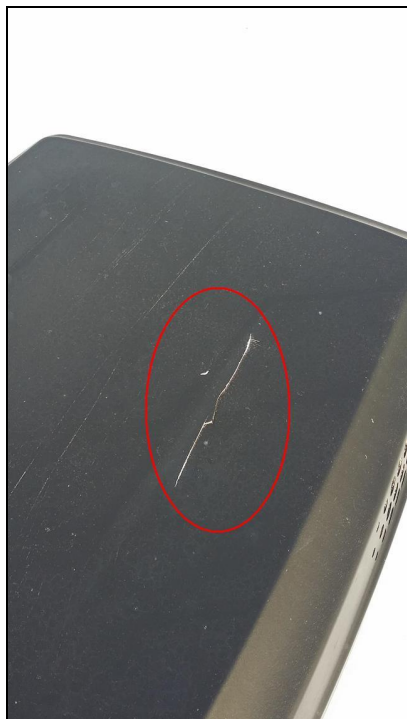
## 2.13 Air Conditioner #2 (Shroud)

**Rear Air Conditioning Unit:** There is a crack on the top of the air conditioner cover.

Fair

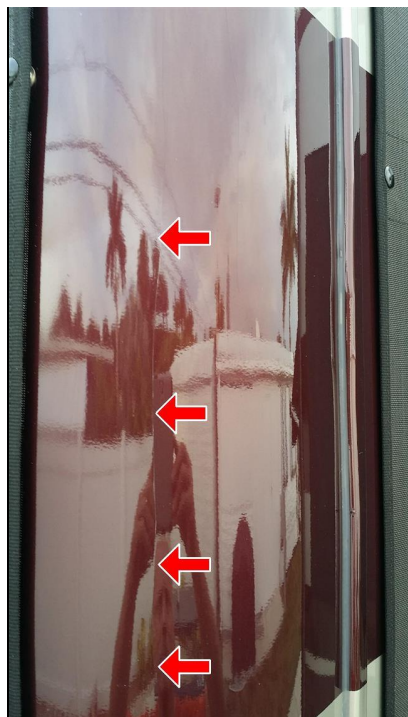
Rear Cap - Curbside Corner

Midway up the curbside rear corner of the rear cap wall, at about eye level, there is a visible 12" long vertical crack in the full body paint's clear coat.

Fair

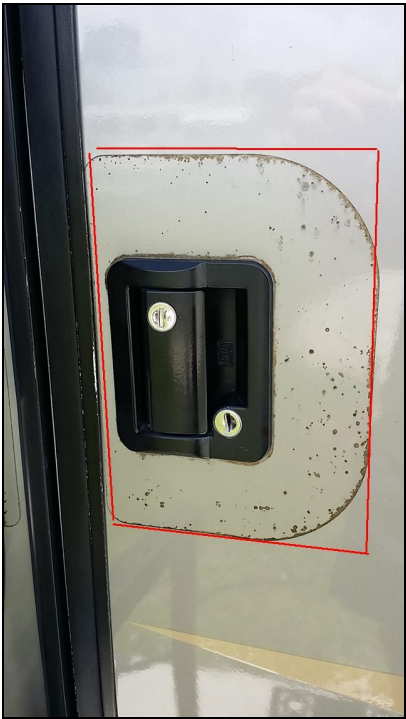
Entrance Door Handle

(1) The Diamond Shield paint protection coating, located around the door handle, is showing signs of deterioration.

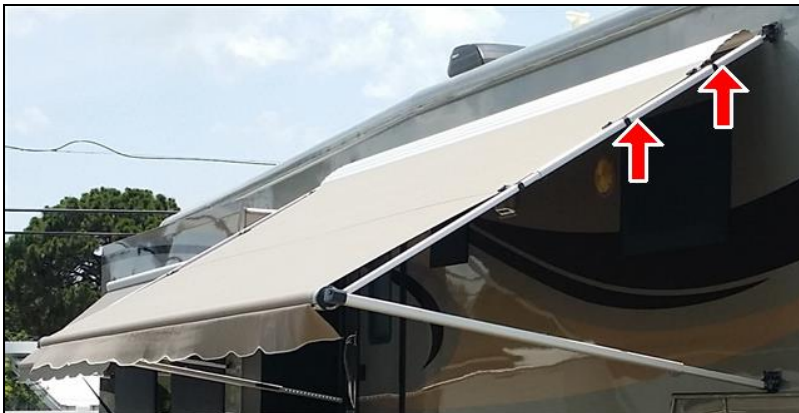
Curbside Wall - Main Awning

The awning appears to be in good shape at the time of the inspection and mostly operates as it is designed to. When retracting the awning it had to be manually rolled up the last two feet of travel in order to get the awning closed. It is recommended that this issue be repaired by a qualified RV technician.

Fair

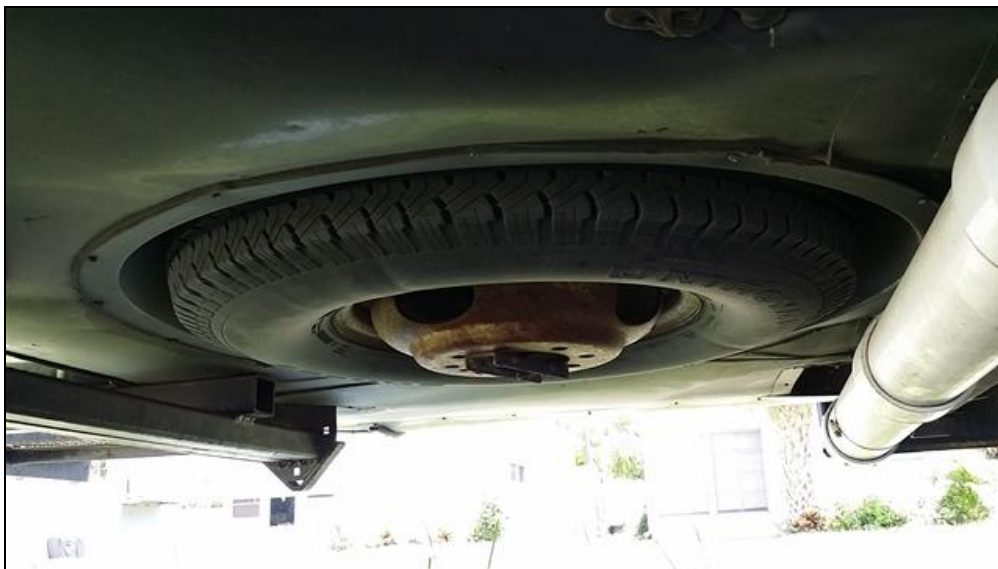
Spare Tire Assembly

Given the inability to determine the age of the spare tire due to its mounted position, it is recommended that the tire be checked by a Certified Tire Specialist for road worthiness. It is also recommended that the tire be inflated to its maximum pressure of 80 psi in case the tire is needed.

### 7.0.E Tire Condition

Acceptable

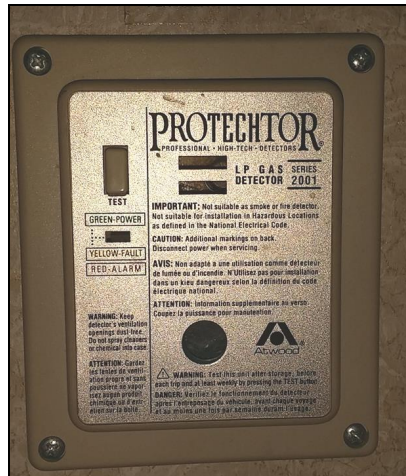
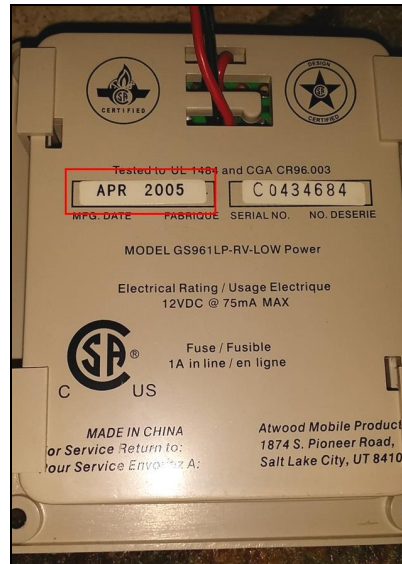
### 13.3 LP Detector

The LP detector located below the bedroom stairs did not go into alarm when tested. Given its manufacture date of April 2005, and that it failed the test, it is recommended it be replaced by a qualified RV technician before the RV is occupied.

Poor

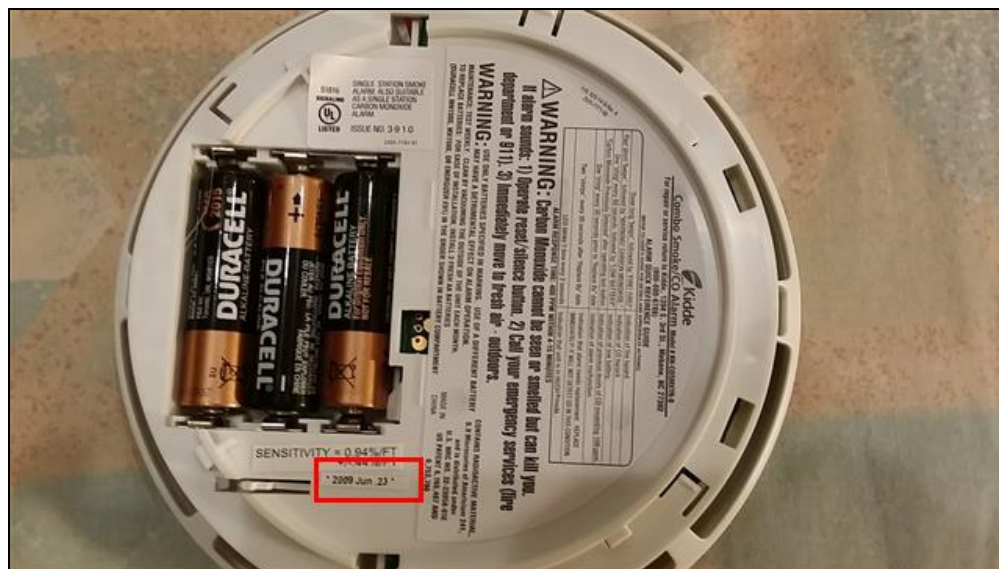
### 13.4 Carbon Monoxide Detector

The combination CO and smoke detector located in the bedroom was manufactured in June of 2009. Even though it passed the push button test, due to its age it is recommended that it be replaced by a qualified RV technician before the RV is occupied.

Poor

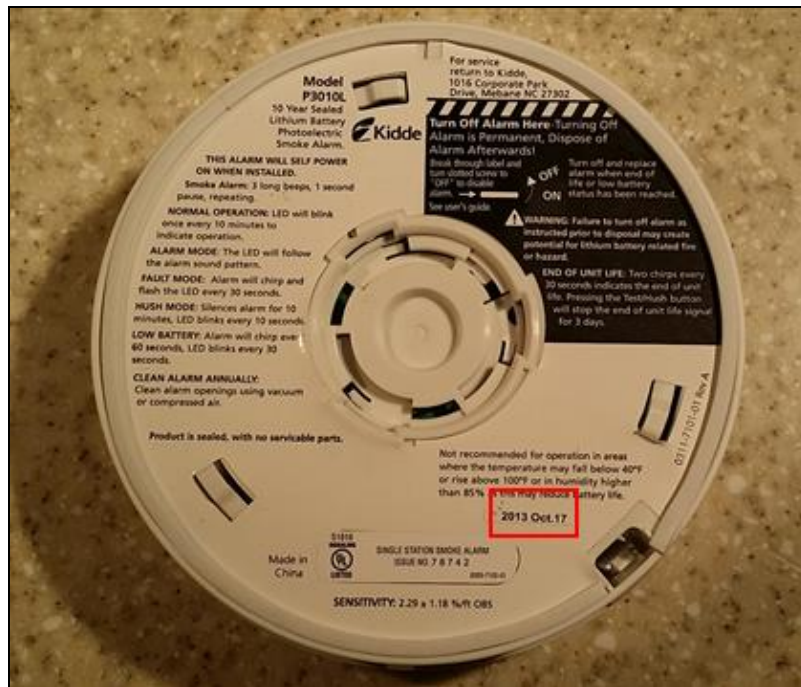
### 13.5 Smoke Detector

The smoke detector located in the living room was manufactured in October of 2013. Even though it passed the push button test, due to its age it is recommended that it be replaced by a qualified RV technician before the RV is occupied.

Poor

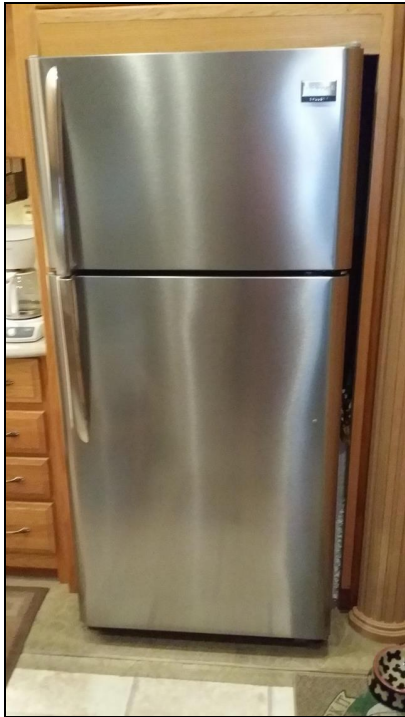
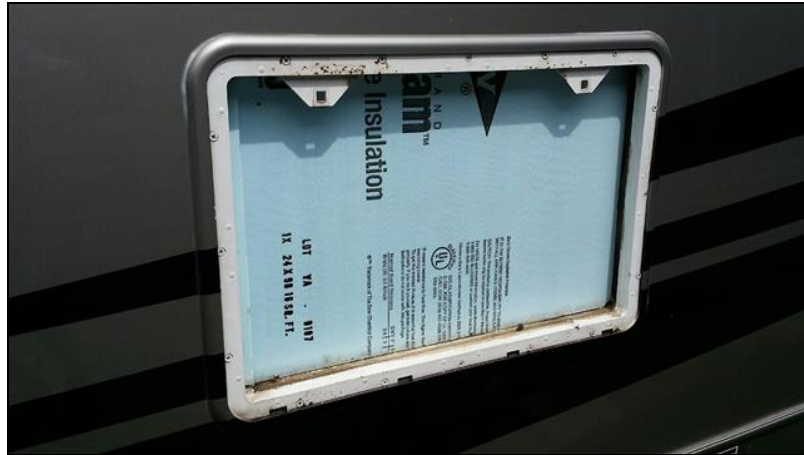
The owner states the previous Norcold refrigerator was replaced with a Frigidaire residential unit in May of 2010. The safety and integrity of the installation and the capping off of the propane line could not be visually verified. It is recommended that the installation be evaluated by a qualified RV technician.

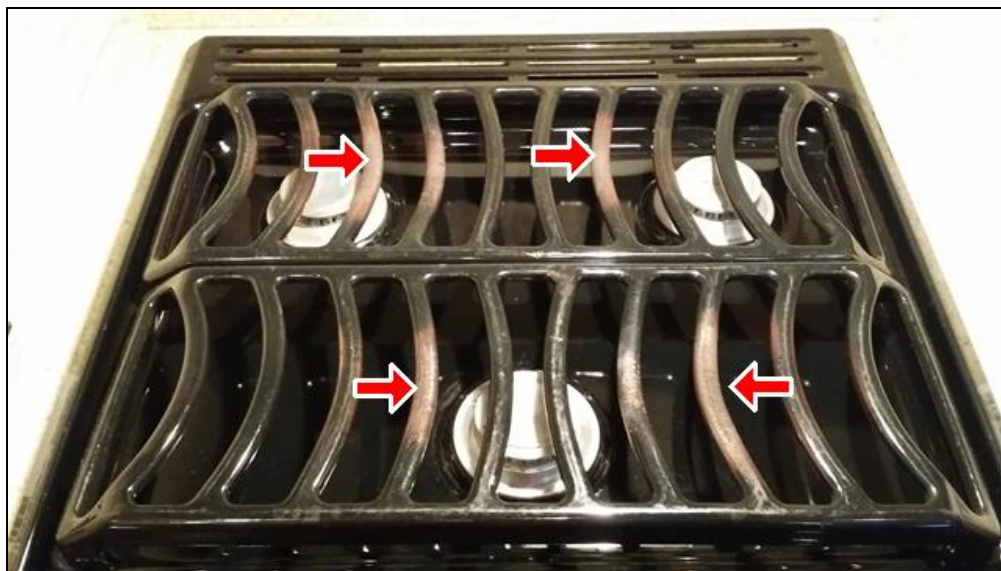
**14.12 Cooktop - Burner Grate Condition**

It was observed that the burner grates are bent and discolored a slight bit.

Fair

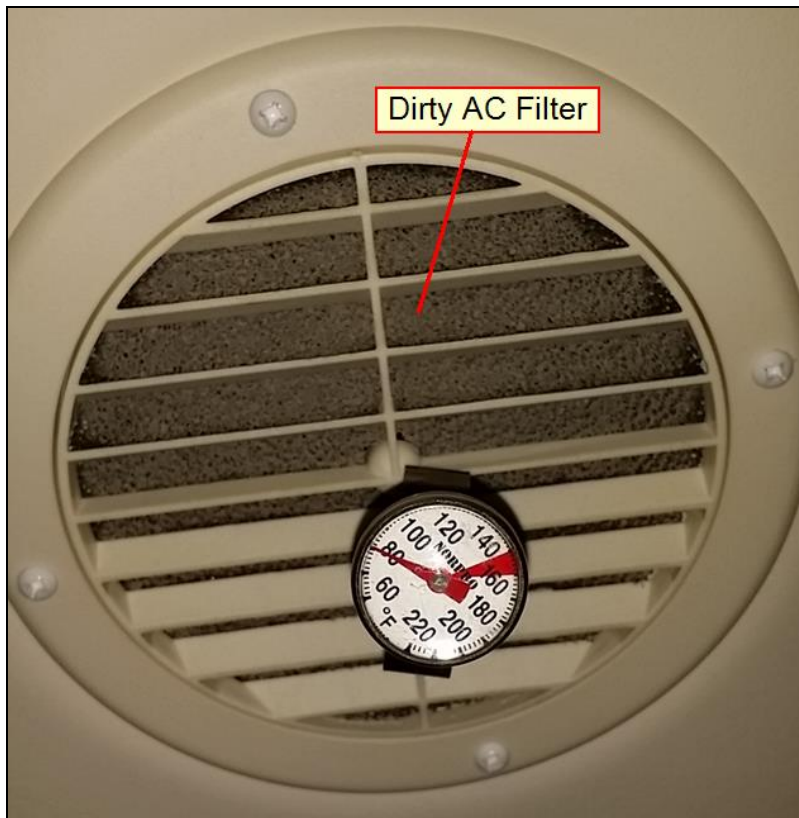
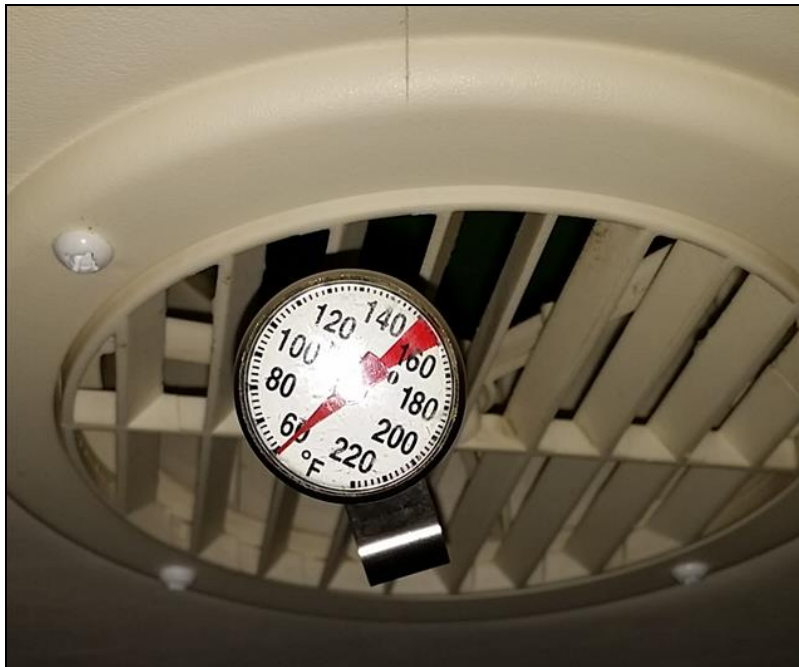
**Rear Air Conditioner:** The Delta-T test resulted in a value of twenty degrees. Although this is acceptable, it is recommended that the air conditioner filters be cleaned.

Fair

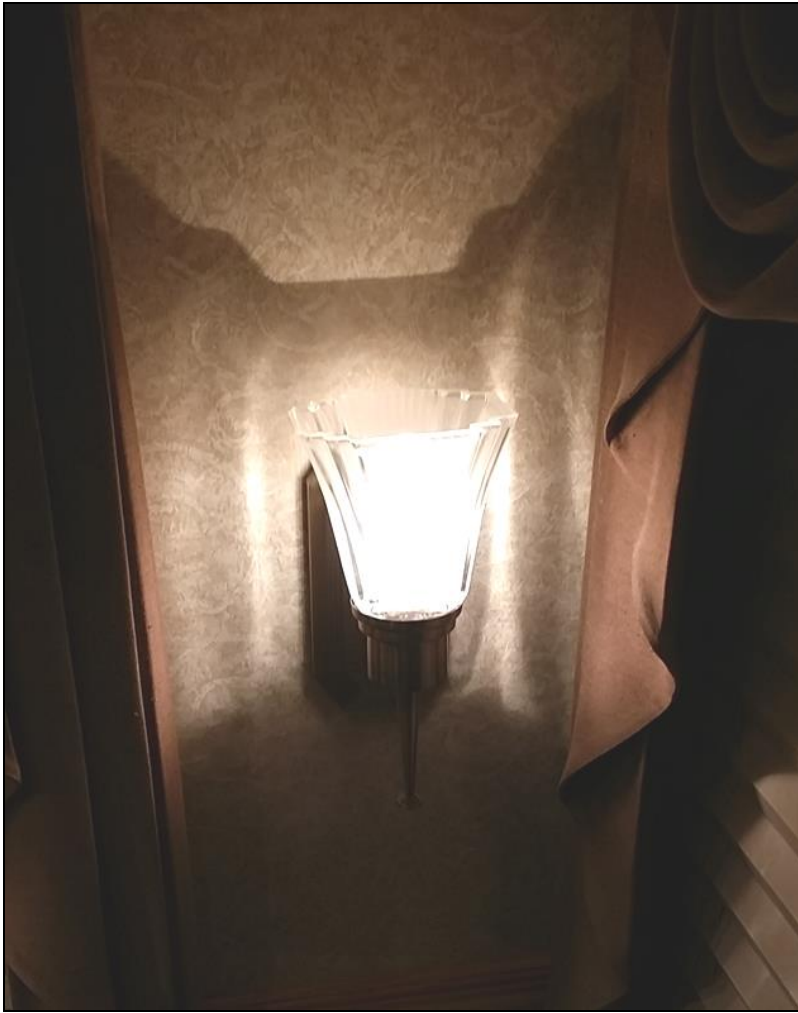
12-Volt DC Sconce Fixture

**12-Volt Light Fixtures:** An odor was observed coming from the sconce located in the rear corner of the curbside slideout room. It is recommended that this be checked by a qualified RV technician.

**12-Volt Light Fixtures:** An odor was observed coming from the scone located in the rear corner of the curbside slideout room. It is recommended that this be checked by a qualified RV technician.

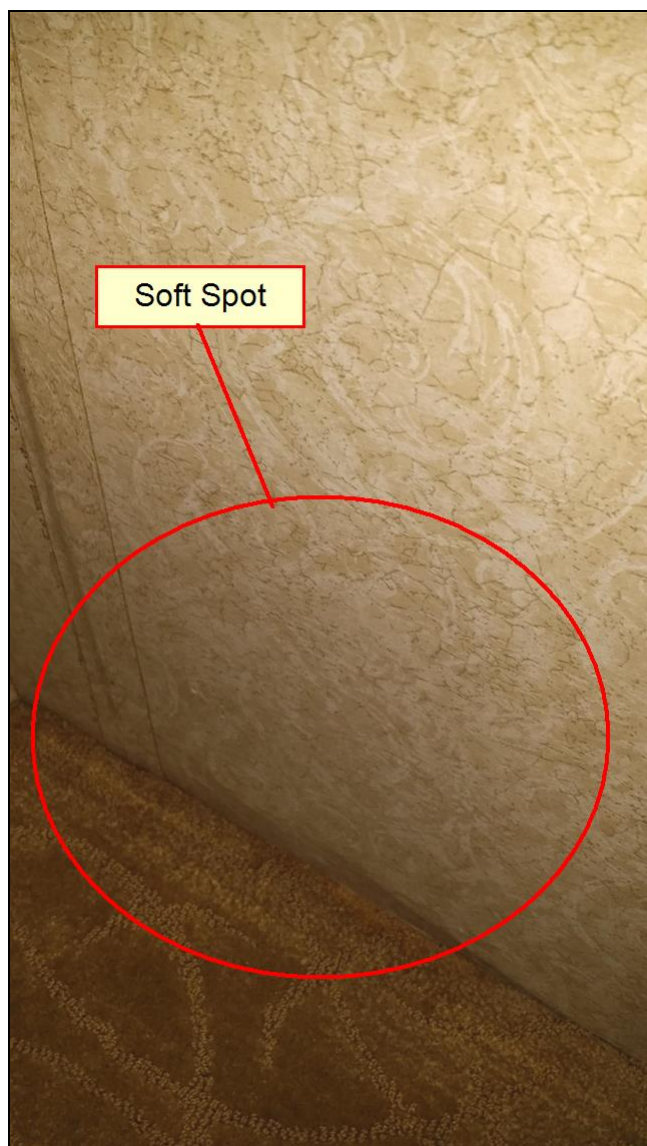
Rear Wall - Curbside Corner

(1) **Damaged Wall Panels:** In the rear of the 5th wheel, in the back of the inside wall near the curbside corner, there is a soft spot where previous water damage may have occurred. The area did not feel wet at the time of the inspection. It is recommended that this be checked by a qualified RV technician for areas of possible water intrusion.

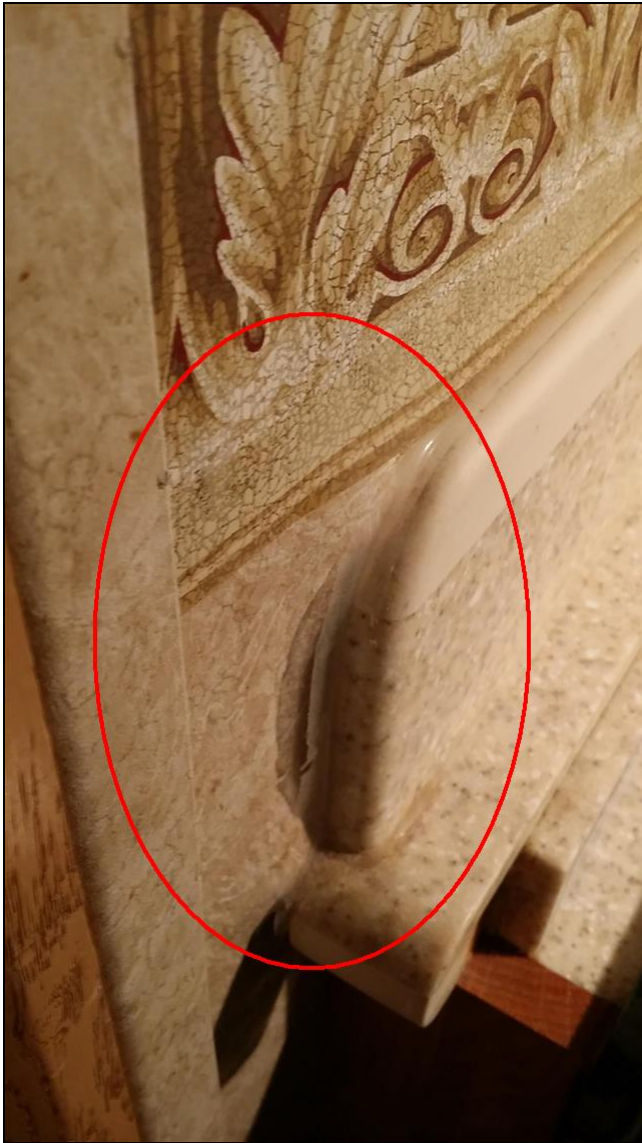
Wall Panel by the Left Side of the Cooktop

(2) **Damaged Wall Panels:** The wall by the left side of the cooktop is bowed and the backsplash is pulling away from the wall panel.

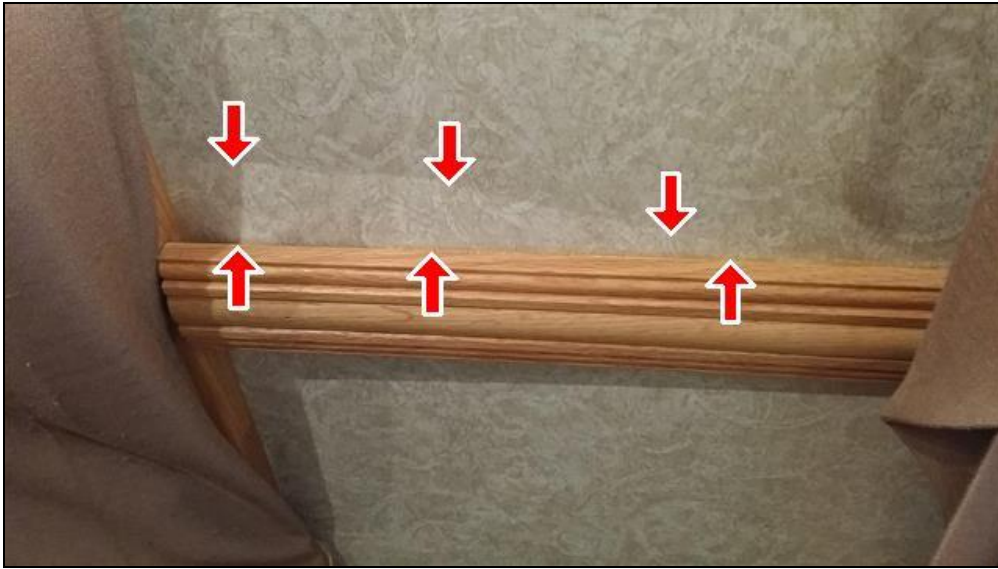
Chair Rail Molding - Curbside Slideout Room

**Wall Trim Work:** On the curbside slideout room there is a loose piece of chair rail molding between the two windows.

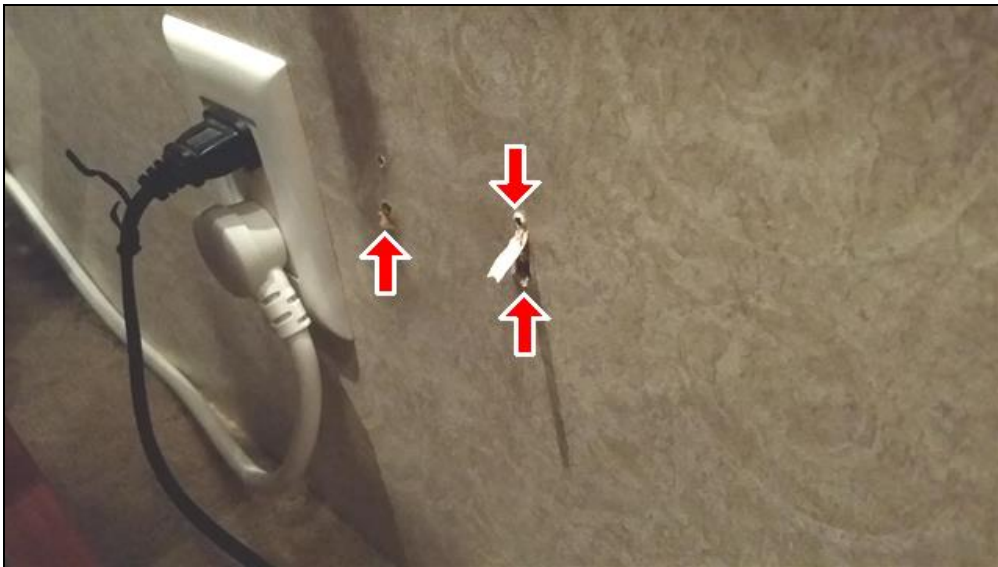
Streetside Rear Corner - Wall Damage

**Interior Wall Holes:** On the streetside rear inside corner of the RV, under the rear streetside window, there is a spot with a few screw holes and some vinyl material pulling away from the wall panel

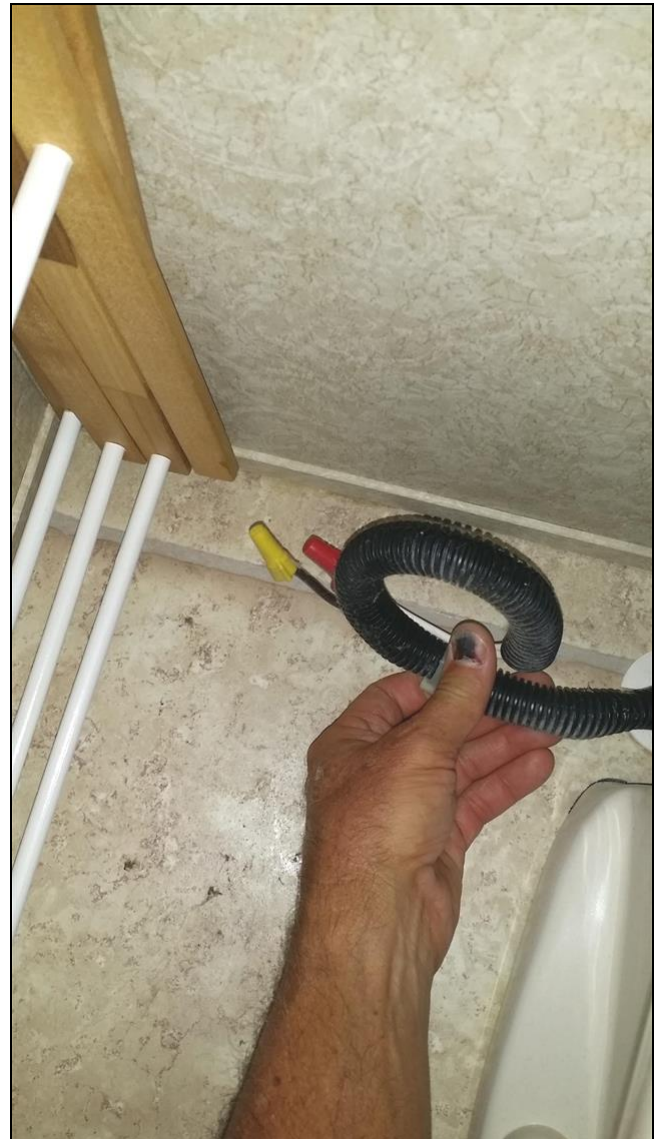
12-Volt DC Wire Harness in Water Closet

It would appear that at one time this RV may have had an electric toilet as observed by the 12-volt DC wire harness that is present.
